Manhole Inspection Summary

Manhole # S08CC2002MH

Location Address: **7062 Glengyle Ave**

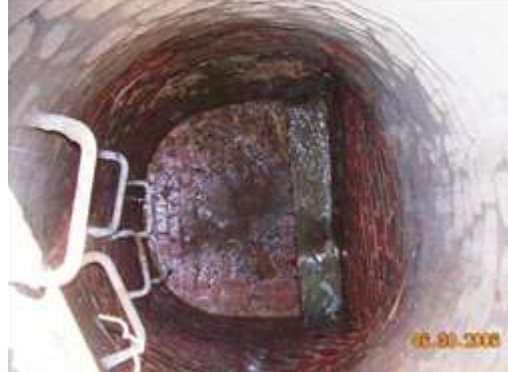
Top View

Frame Offset: **0** (in.) Condition: ☐ Sound ☐ Cracked ☒ **Leaks**

Condition: ☐ Sound ☐ Cracked ☐ Root Intrusion ☒ **Loose Brick** ☒ **Deteriorated**

Infiltration: ☐ None ☒ **Joint** ☐ Cracks ☐ Mortar ☐ Roots ☒ **Wall**
